# TOYOTA

Ref. No.: SL01/11

**Model:** Land Cruiser VDJ200, VDJ76 / 78 / 79

**Subject: 1VD-FTV ENGINE OIL USAGE**

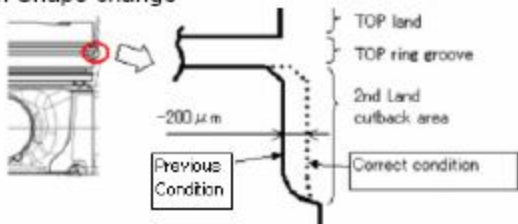
No	Description	Production effective
1	<p>Piston Shape change</p>

<p>The diagram shows a cross-section of a piston with a red circle highlighting the crown. An arrow points to a detailed view of the crown profile. The 'Previous Condition' shows a profile with a sharp corner and a '2nd Land curback area'. The 'Correct condition' shows a profile with a rounded top and a 'TOP land' and 'TOP ring groove'. A dimension of <math>-200\mu\text{m}</math> is indicated between the two profiles.</p>	<p>Engine No. Breakpoint: 1VD-0043952 ~</p> <p>Effective Sept 2008</p>
2	<p>Vacuum pump exhaust port size reduced</p>

Engine No.	Repair method - replace		
	Piston	Vacuum Pump	Turbo Oil Pipe Flange
Before ~ 1VD-0043951	✓	✓	✓
1VD-0043952 ~ 1VD-0050094		✓	✓
1VD-0050095 ~ 1VD-0092701			✓
After 1VD-0092702

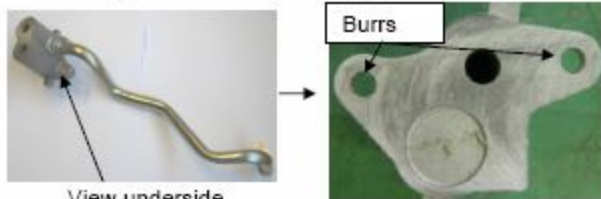
3	<p>Poor sealing Turbo Oil Pipe Flange due to burr</p>

<p>The photograph shows a Turbo Oil Pipe Flange. The left image is labeled 'View underside' and shows the flange with a burr. The right image is labeled 'Burr' and shows a close-up of the burr on the flange.</p>	<p>Engine No. Breakpoint: 1VD-0092702 ~</p> <p>Effective June 2010</p>

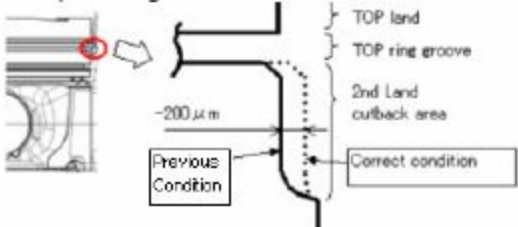
No	Description	Production effective
1	<p>Piston Shape change</p>

<p>The diagram illustrates a change in the piston's top land profile. On the left, a cross-section of the piston is shown with a red circle highlighting the top land area. An arrow points to a detailed profile comparison. The 'Previous Condition' shows a top land with a specific profile, while the 'Correct condition' shows a modified profile with a '2nd Land cutback area'. Labels include 'TOP land', 'TOP ring groove', and '2nd Land cutback area'. A dimension of <math>-200\ \mu\text{m}</math> is shown between the two profiles.</p>	<p>Engine No. Breakpoint: 1VD-0043952 ~</p> <p>Effective Sept 2008</p>
2	<p>Improved sealing - scavenge pipe &amp; oil pan No. 1. Gaskets adopted</p>

Engine No.	Repair method - replace		
	Piston	Scavenge Pipe Gasket	Turbo Oil Pipe Flange
Before ~ 1VD-0043951	✓	✓	✓
1VD-0043952 ~ 1VD-0064906		✓	✓
1VD-0064907 ~ 1VD-0092688			✓
After 1VD-0092689

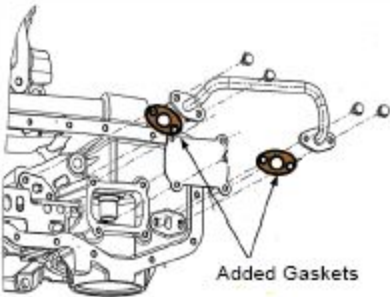
<p>An exploded view diagram of engine components, including the scavenge pipe and oil pan No. 1. Two gaskets are highlighted with circles and labeled 'Added Gaskets'.</p>	<p>Engine No. Breakpoint: 1VD-0064907 ~</p> <p>Effective April 2009</p>

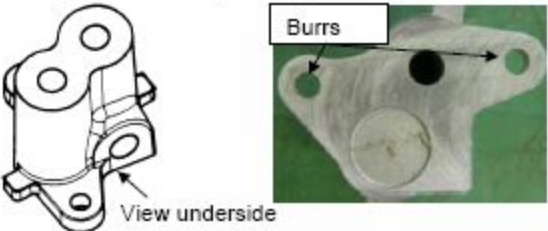
3	<p>Poor sealing Turbo Oil Pipe Flange due to burr</p>

<p>The diagram shows a Turbo Oil Pipe Flange. On the left is a line drawing labeled 'View underside'. On the right is a photograph of the flange with a black arrow pointing to a sharp edge labeled 'Burr'.</p>	<p>Engine No. Breakpoint: 1VD-0092689 ~</p> <p>Effective June 2010</p>
