Battery Excessive Draw - Integration Relay

Service Category Power Source/Network

Section Power Distribution

YEAR(S)	MODEL(S)	ADDITIONAL INFORMATION
2011	Sienna	Body Type(s): Van Drive Type(s): 4WD, 2WD Engine(s): 2GR, 1AR Plant Code(s): S Transmission(s): 6AT VDS(s): DK3DC, JK3DC, KA3DC, KK3DC, XK3DC, YK3DC, ZK3DC WMI(s): 5TD

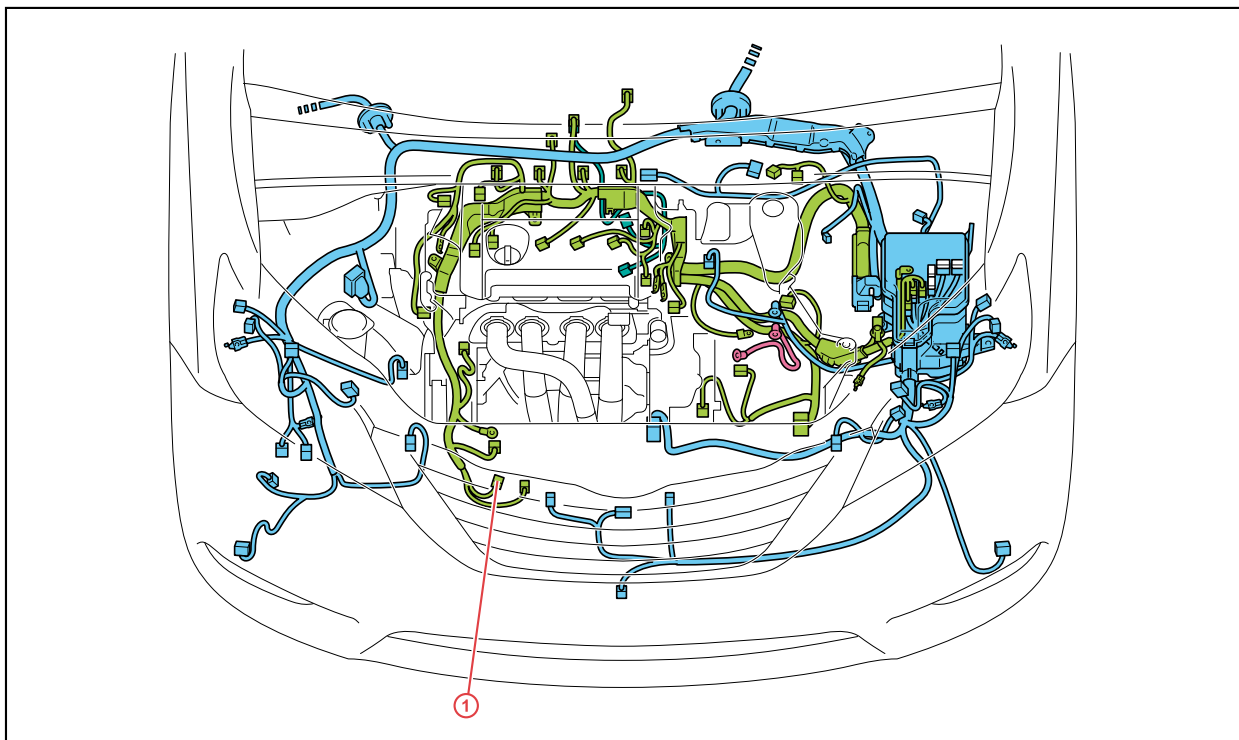
Figure 1. Connector B41 Location

1 B41 Connector

3. With the ignition key in the "OFF" position, disconnect connector B41 and verify the A/C clutch audibly clicks "OFF". If a click is heard proceed to step 4.
4. From the front side of the connector, confirm battery voltage on A/C clutch B41 connector. If battery voltage is present, proceed to step 5.
5. Replace Integration Relay.
